# APPLICATION REVIEW

### Pulp and Paper Mill Cuts Maintenance Costs and Improves Operations with Salt Cake Conveyor Redesign

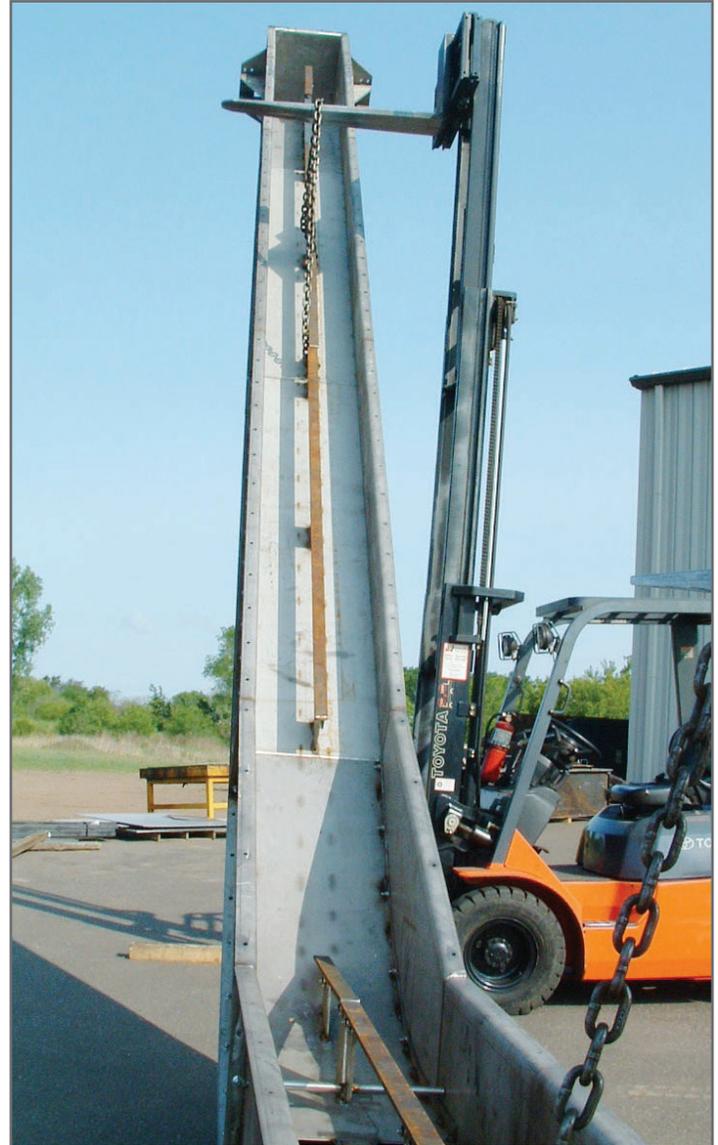
The conveyor housing prior to sand blast. This shows the return side of the chain with the new replaceable wear rails.

the chain speed was kept at a minimum to reduce wear. The CDM retrofit conveyors were designed with robust construction. The original sidewalls of the conveyors were 7 GA with a  $\frac{1}{4}$ " bottom plate. The new CDM supplied conveyors had  $\frac{5}{16}$ " thick sidewalls and  $\frac{1}{2}$ " thick bottom plates. CDM also supplied replaceable wear rails in the conveyor bottom plate to further protect the stainless steel from galling caused by the chain. The wear rail is located

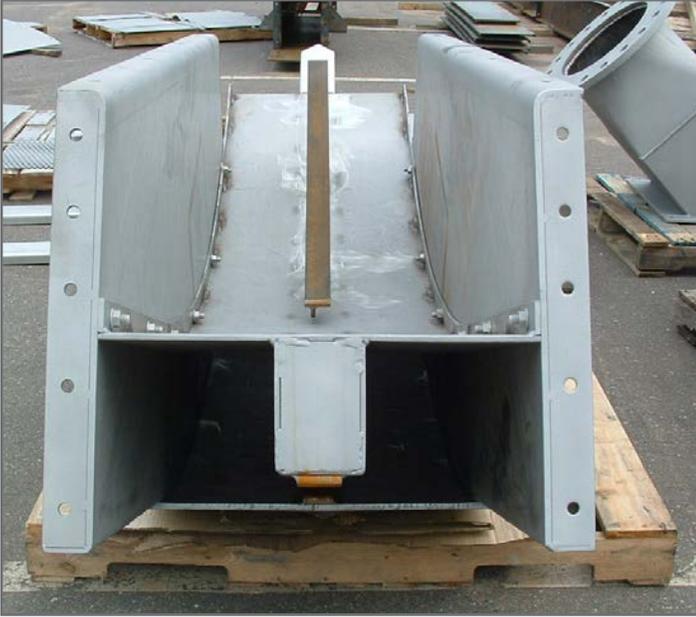
The newly designed bend section of the conveyor. The new thick bottom plate with wear rails coupled with the stainless material will prevent the vapor from corroding the housing and components.

down the center of the conveyor and elevates the chain off the conveyor bottom plate.
