Pulp and Paper Manufacturer  
**Pulp and Paper Mill Gets Positive ROI in Less  
than 12 Months with Conveyor Retrofit**

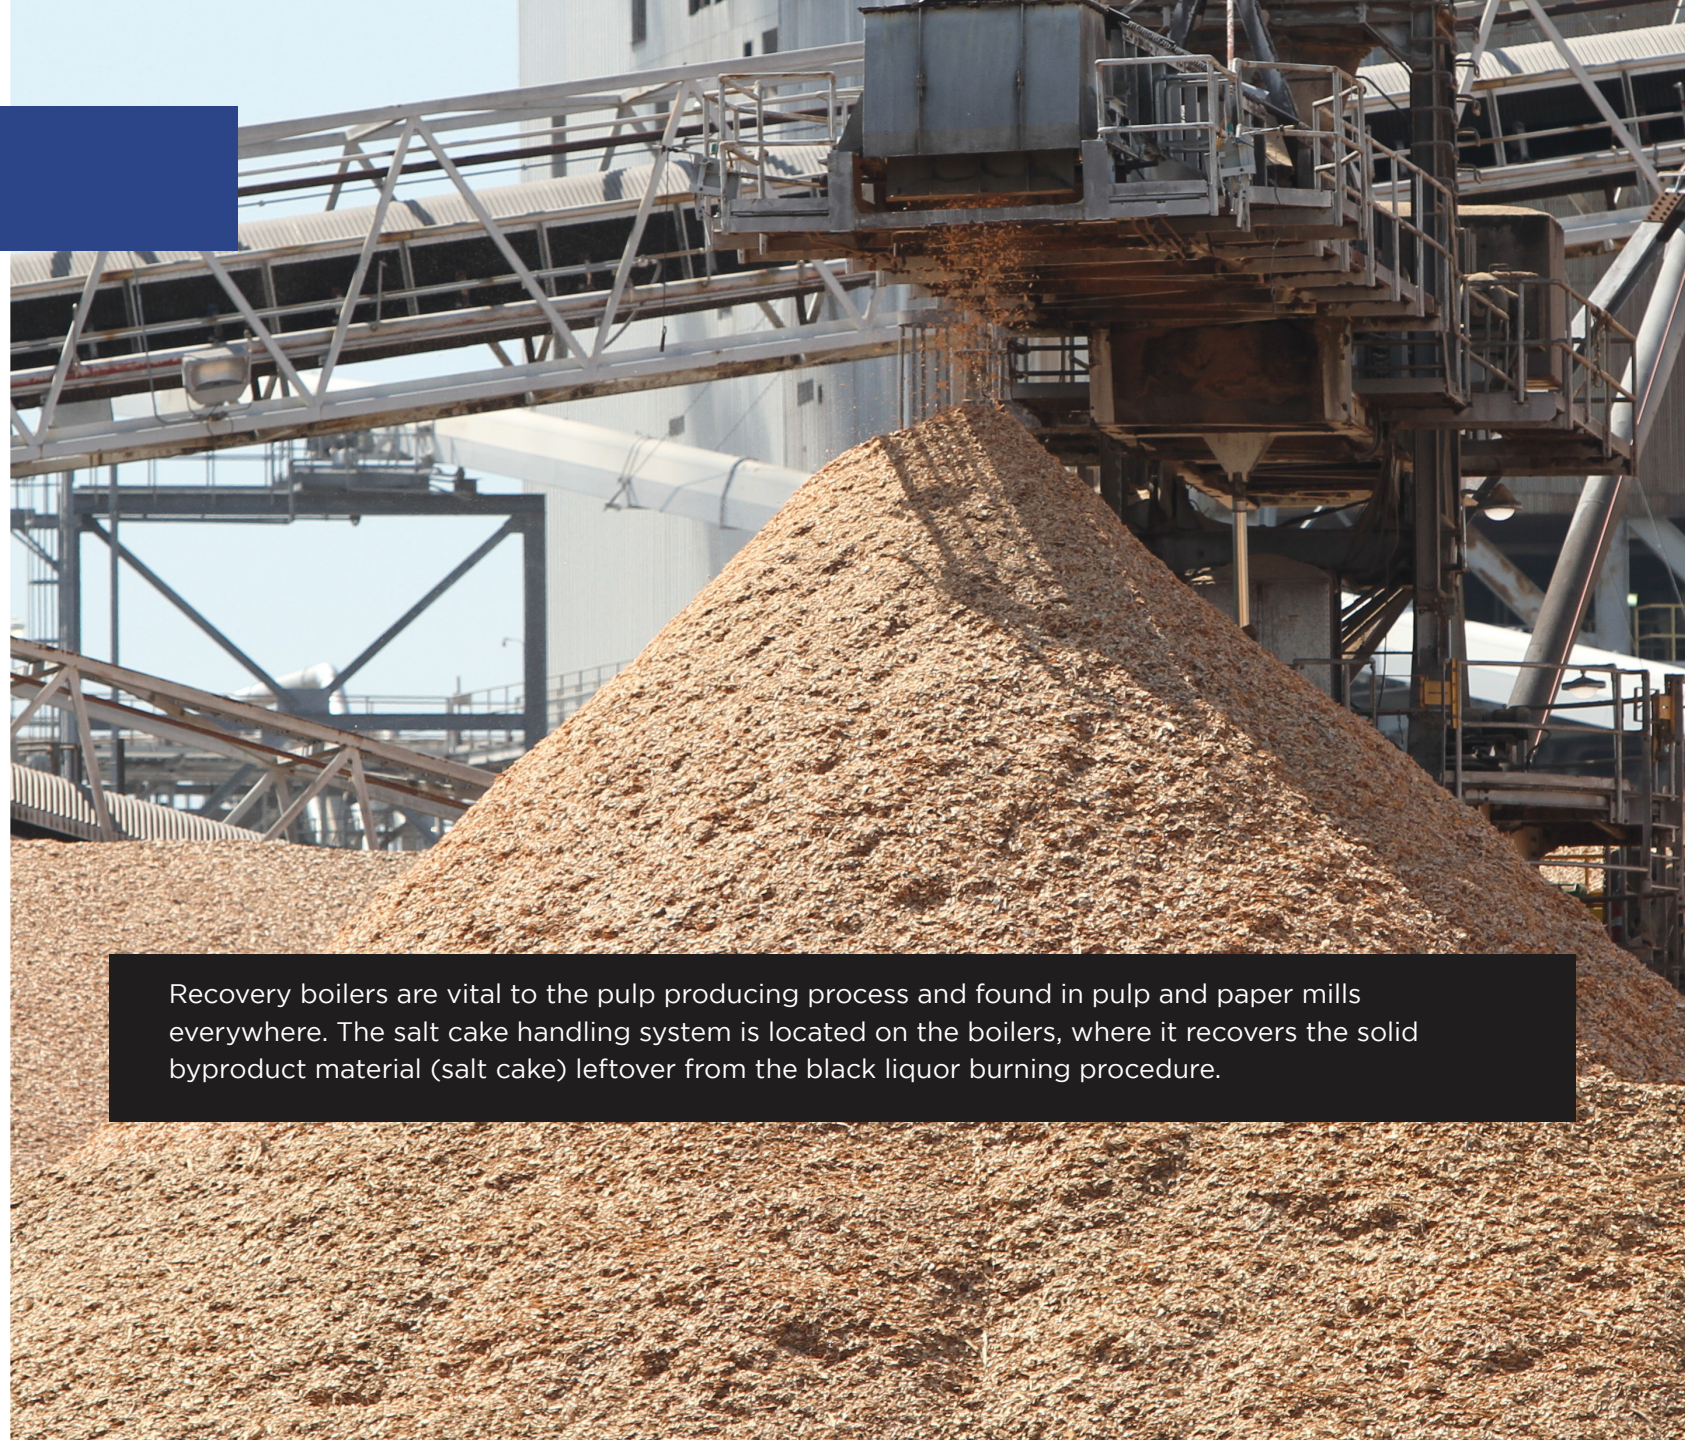
During the pulping process, vapor from the black liquor tanks severely corroded the housing, drive assembly and chain of the conveyor. The corresponding failure led to high maintenance requirements and frequent downtime.

Recovery boilers are vital to the pulp producing process and found in pulp and paper mills everywhere. The salt cake handling system is located on the boilers, where it recovers the solid byproduct material (salt cake) leftover from the black liquor burning procedure.

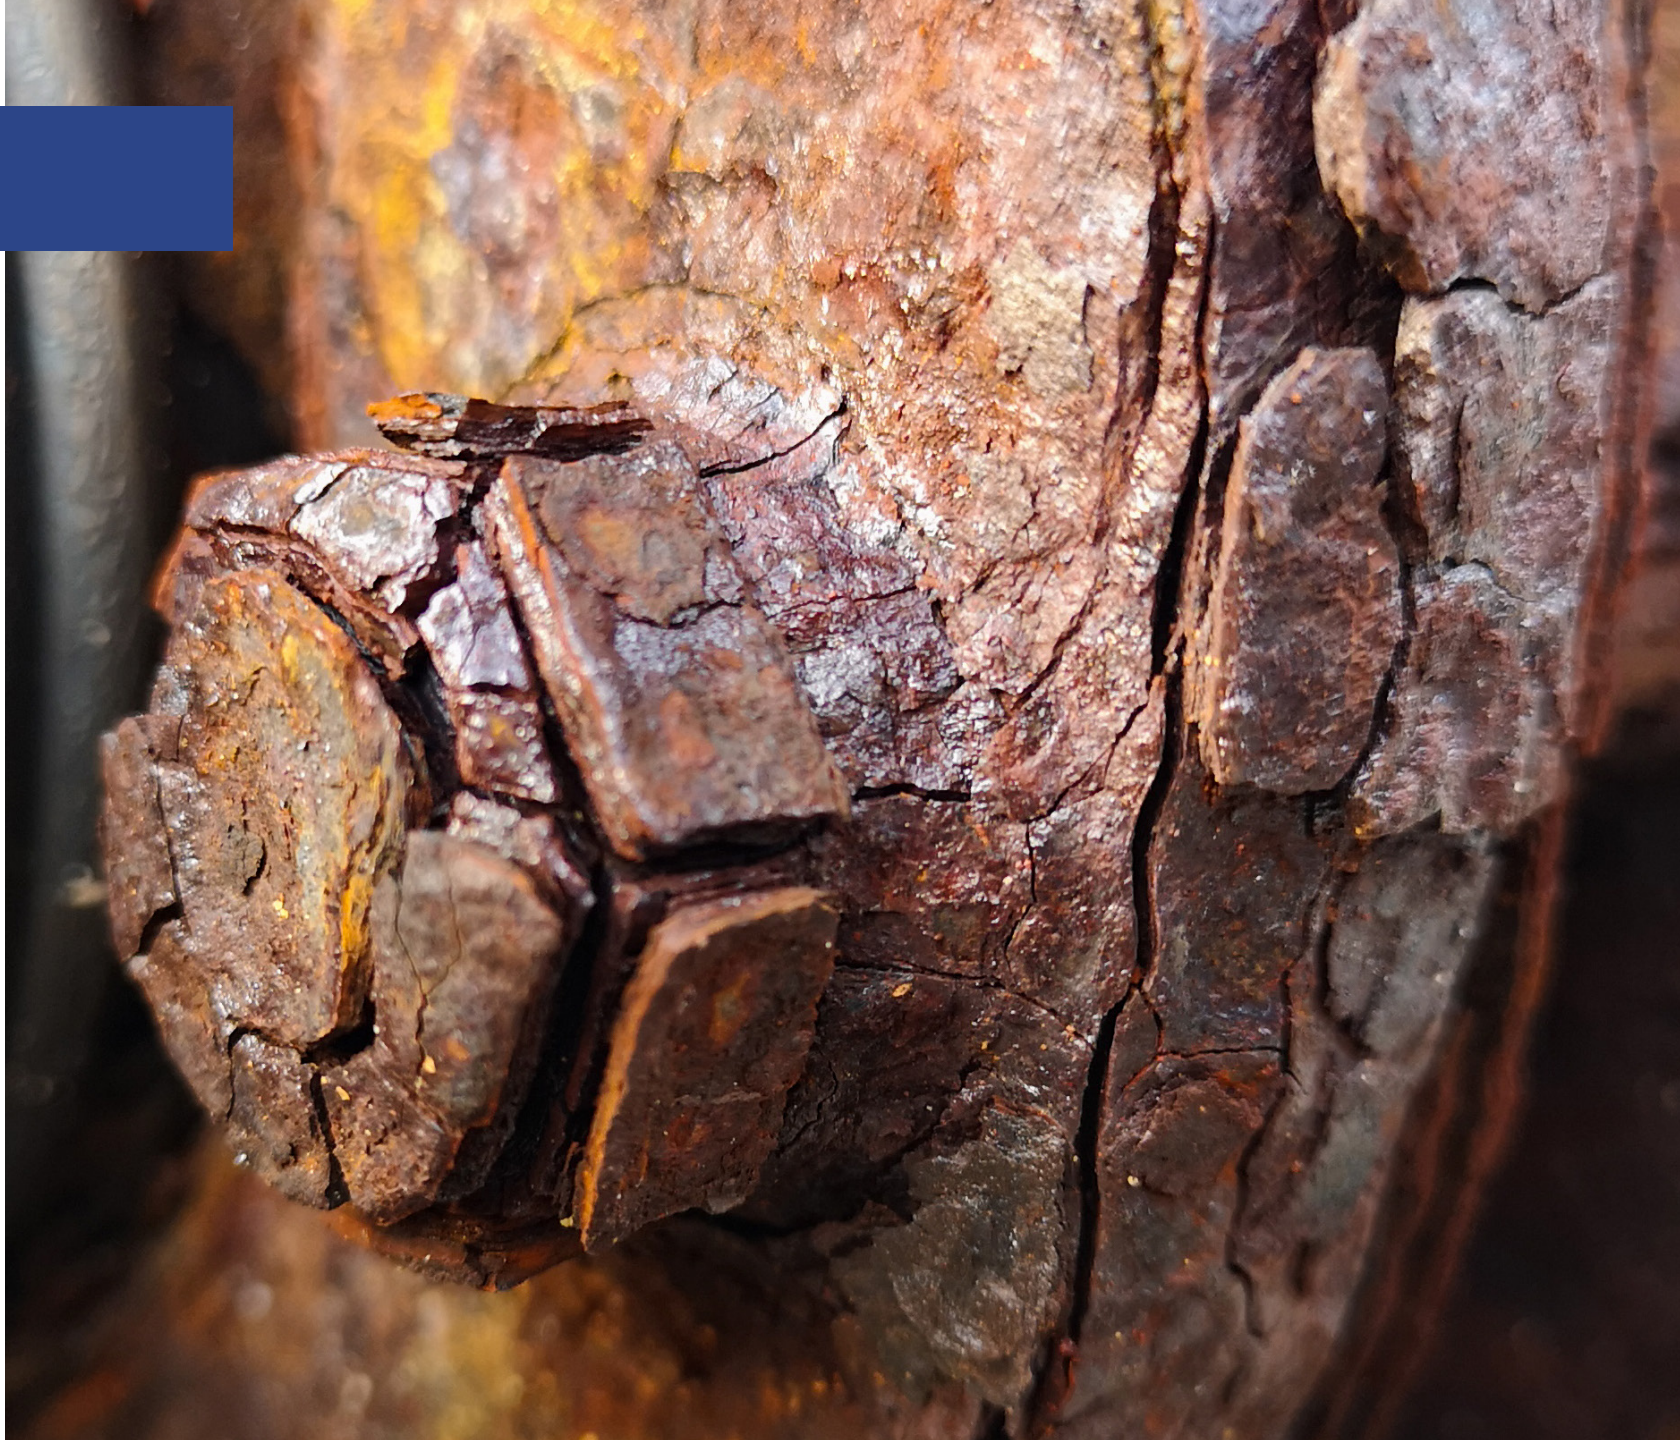
When CDM inspected the existing equipment they found the vast majority of corrosion occurred near the drive/discharge end of the conveyors. This was due to the incline of the conveyors and where the vapor was being trapped. After evaluating the operating conditions, the CDM team concluded the best option was a retrofit of the existing conveyors fabricated from a stainless steel housing.

CDM designed the conveyor components with stainless steel to resist corrosion. It is a softer metal with lower heat treat limits and is more susceptible to erosion, but CDM countered this by keeping the chain speed at a minimum to reduce wear. Thicker sidewalls and bottom plates provided additional protection to the stainless steel components.

This configuration allowed the mill to simply add the flight extensions to suit the chain. CDM worked with the mill's staff to retrofit the conveyors within an existing maintenance budget. CDM then reviewed the design of the structural steel connections and anchor points and found that they could be reused – along with many other components.
