Wood Products Manufacturer
**En-Masse Twin Chain Retrofit Gets Operation
Running at Full Capacity**

THE SITUATION

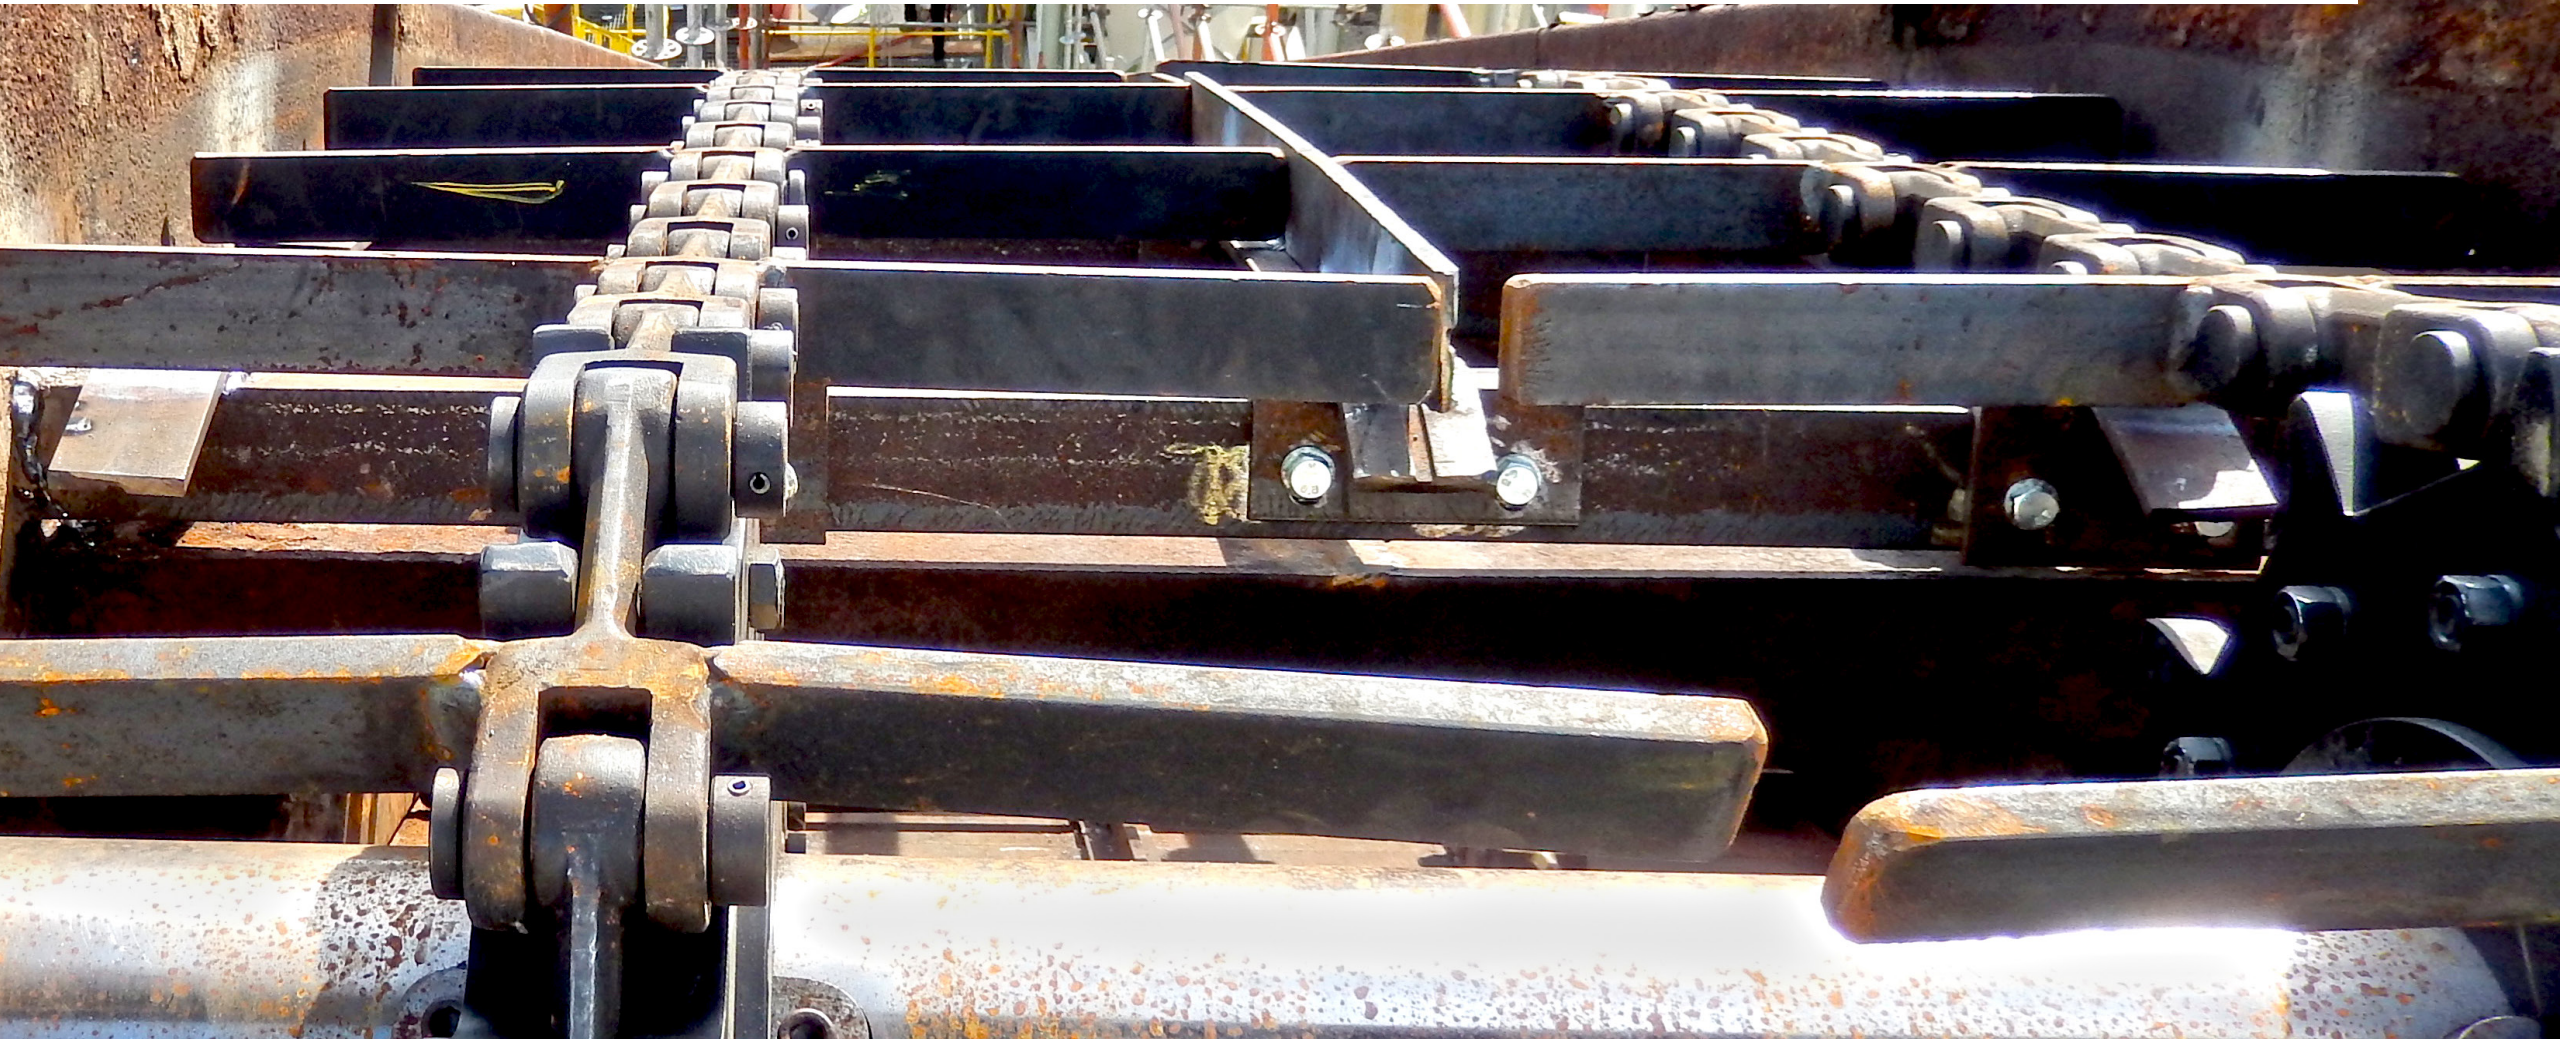
A Brazilian manufacturer of OSB and MDF wood-based products used en-masse conveyors to move raw materials from off-load to distribution and manufacturing. Poor design and small conveyor size—complicated by incorrect flight selection—meant the conveyors could not handle the required loads or the characteristics of the material.

**THE CONVEYORS NEEDED
A REDESIGN TO IMPROVE
OUTPUT CAPACITY.**

CDM redesigned the undersized conveyors to handle the full volume of chips and flake. The primary conveyor needed to handle product from six flakers without plugging and shutting down.

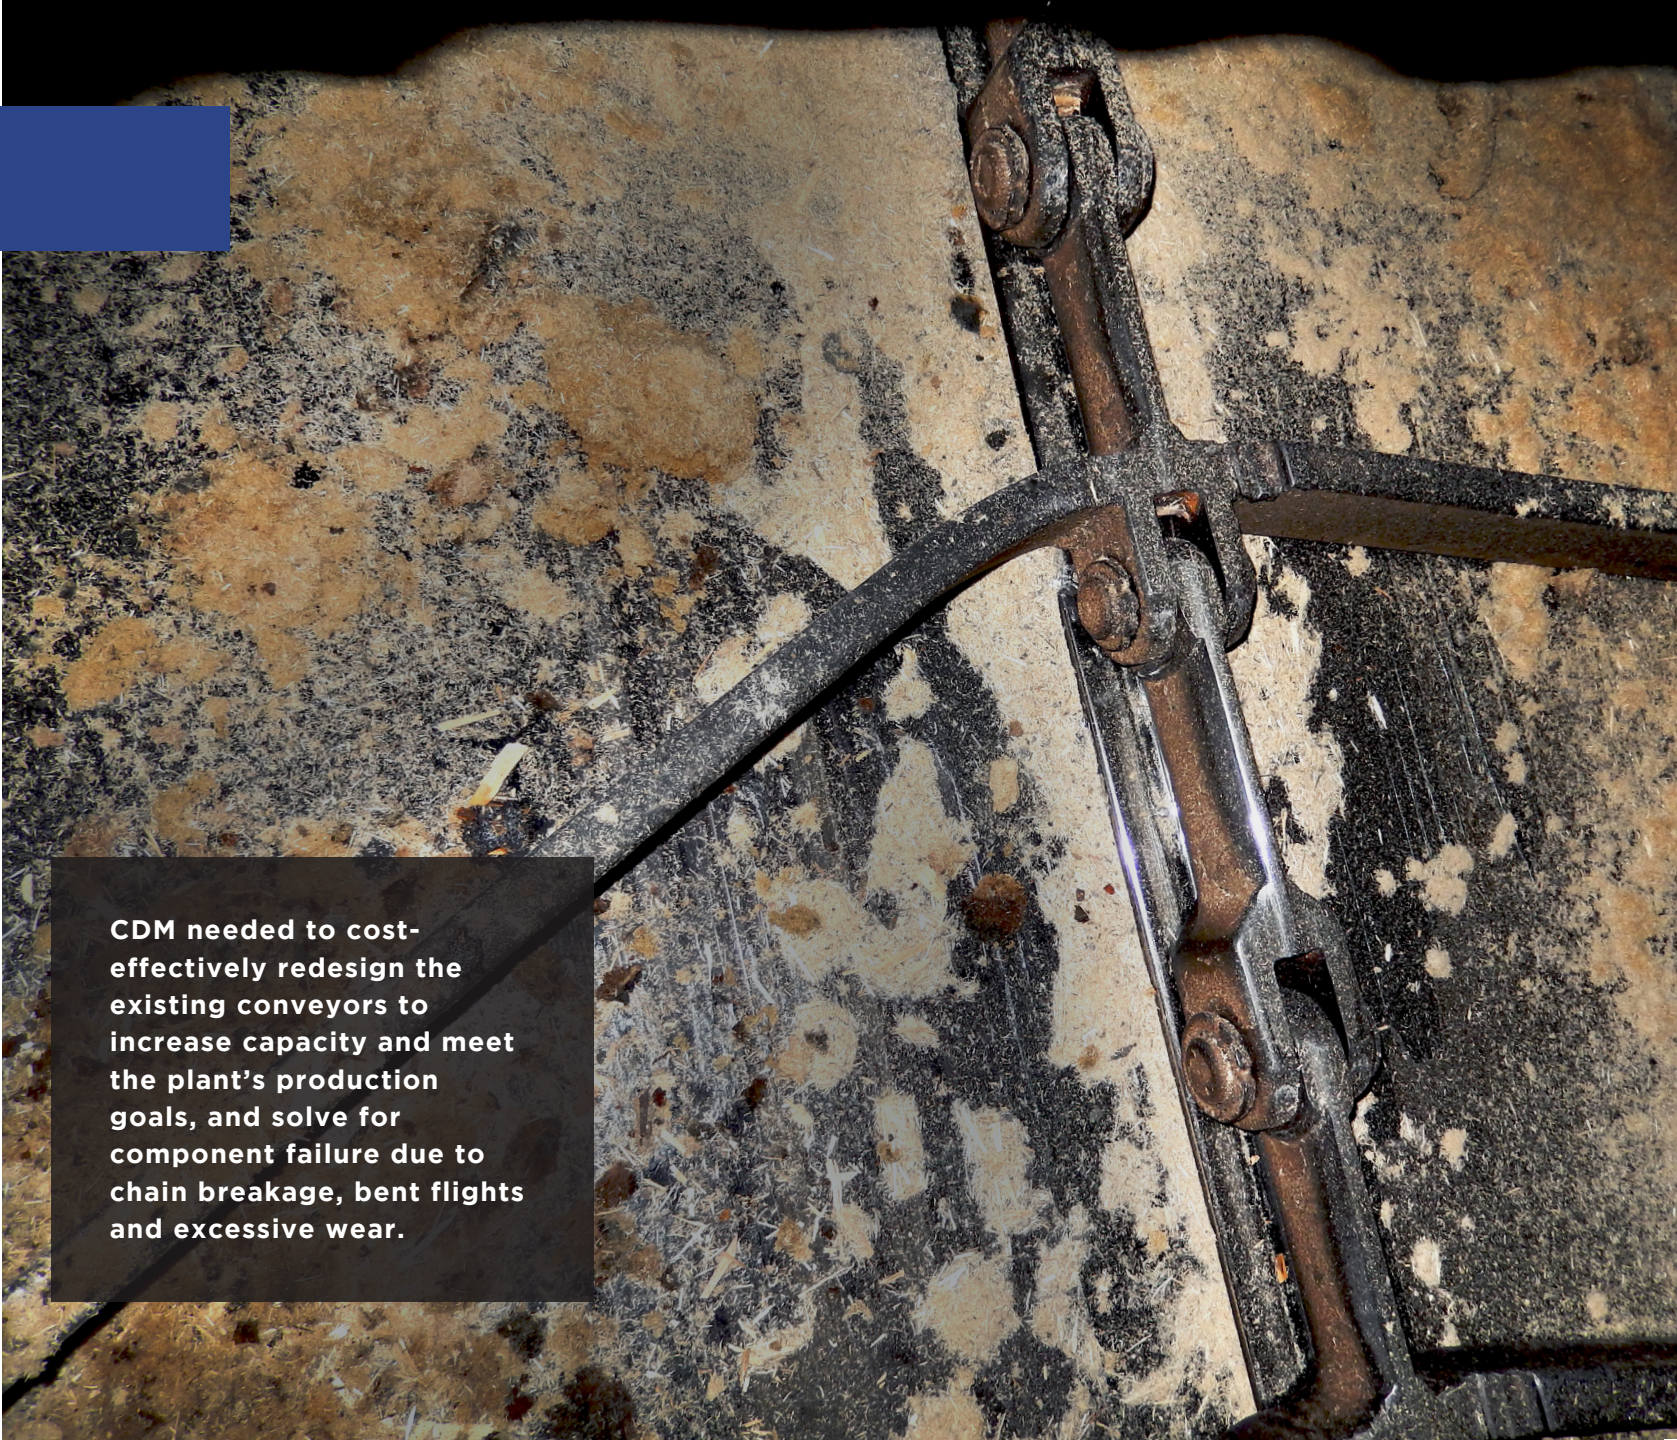
- Conveyors did not meet design capacity criteria
- Improper chain application
- Undersized and misapplied gear reducer
- Poorly designed conveyor housing and return system

CDM needed to cost-effectively redesign the existing conveyors to increase capacity and meet the plant's production goals, and solve for component failure due to chain breakage, bent flights and excessive wear.

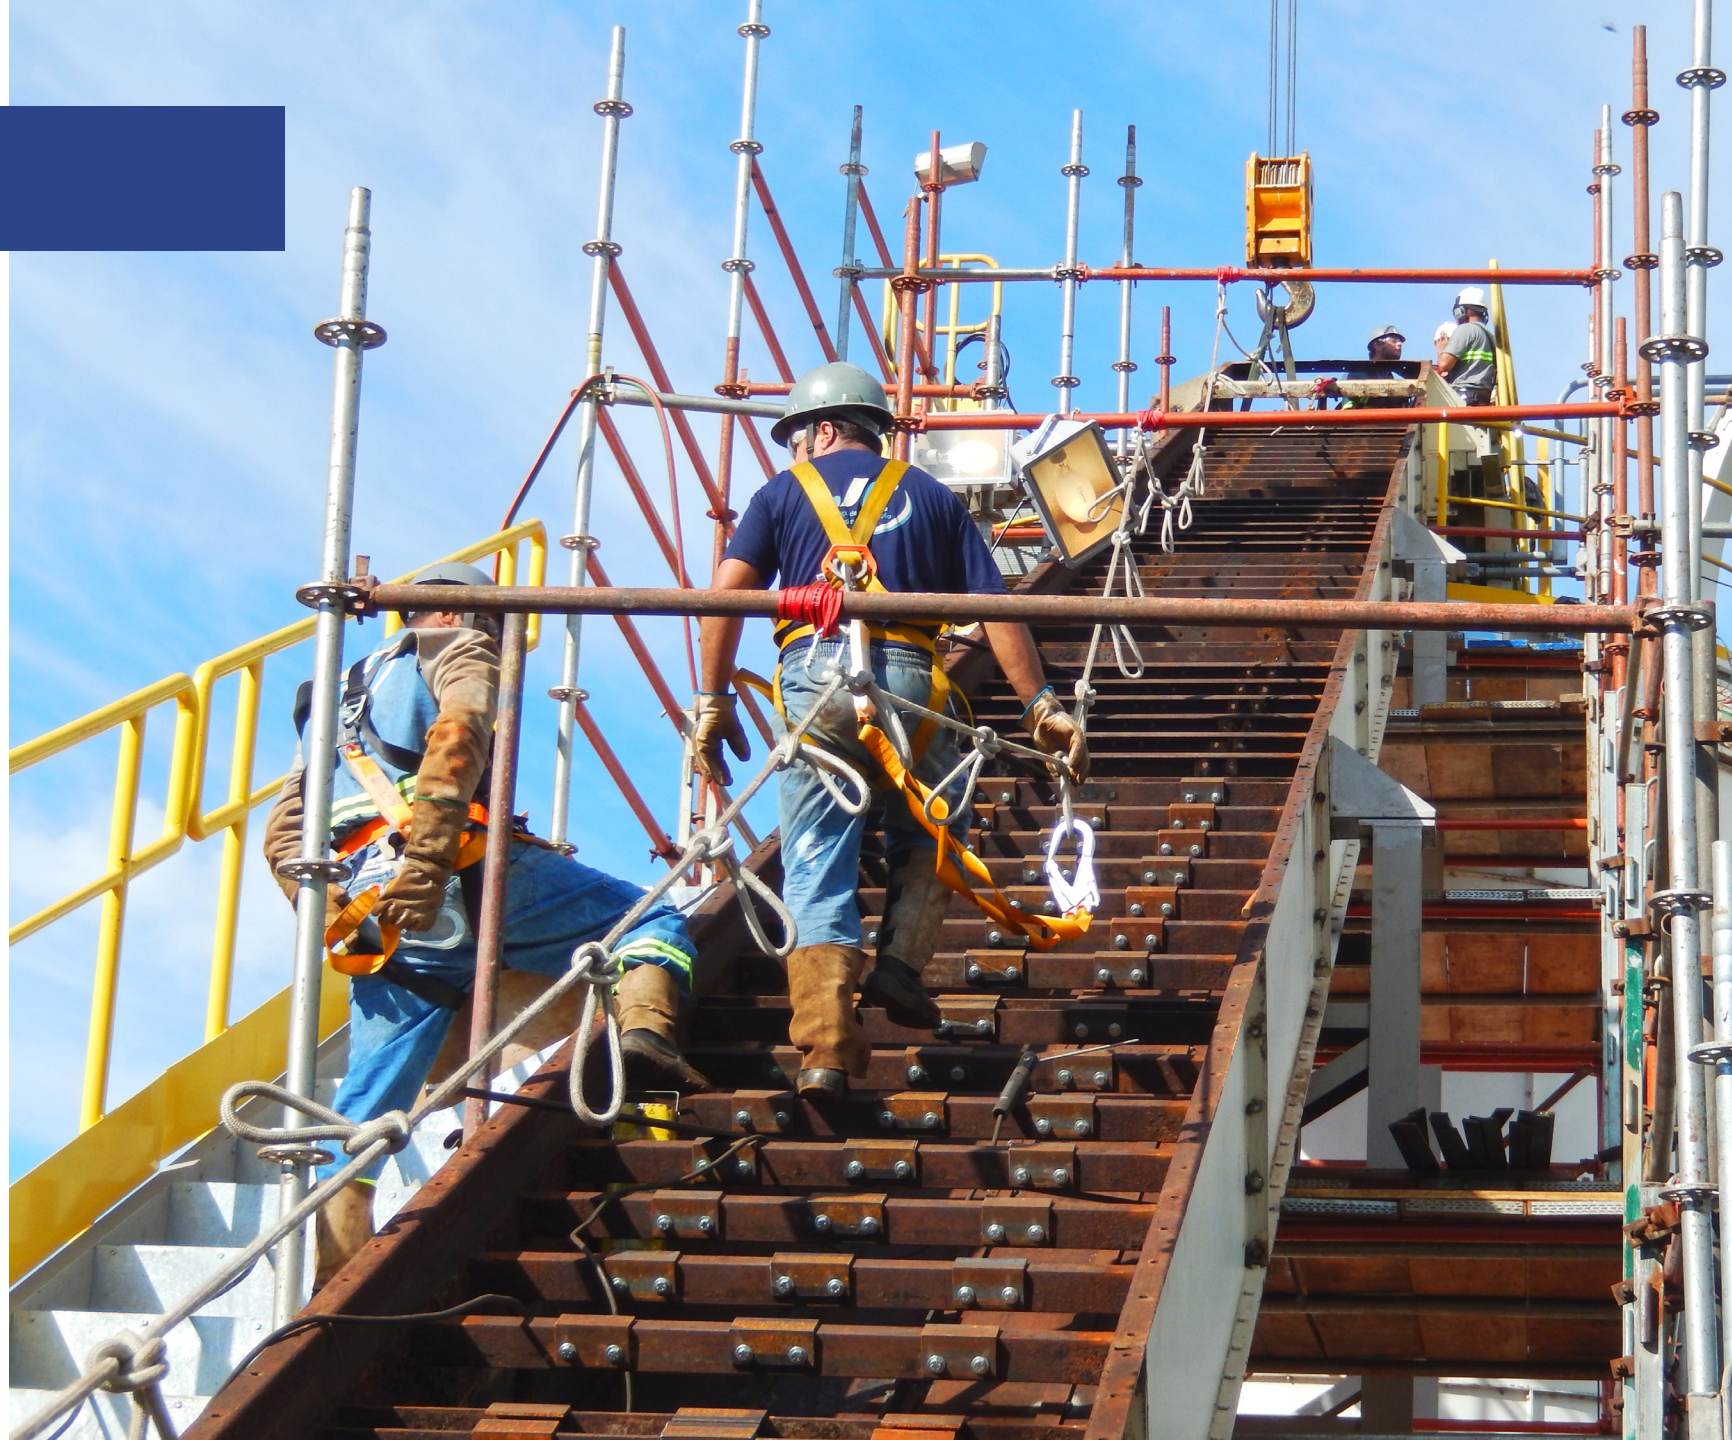
Redesign strategy: Increase the conveyor's sidewall height

Redesign method: Bolt formed channels to the existing sidewall

These extensions, combined with elevating the chain return rail, increased the area required to meet the capacity without increasing chain speed.

A zero speed switch and a CDM-exclusive Kick-Out End Flap were added to each conveyor, serving as a plug chute and chain break indicator. These significantly reduced damage and downtime.

Another trouble spot was the misapplication of the chain. Because no two strands of chain wear at exactly the same rates, a conveyor can eventually fail when the chain lengths become uneven. CDM corrected this with its exclusive Twin-Strand design, which has independent take-ups/chain tensioning.
